Proposal for Seismic Retrofit Design of a Traditional Residential Building in Antakya (Structural Design Proposal)

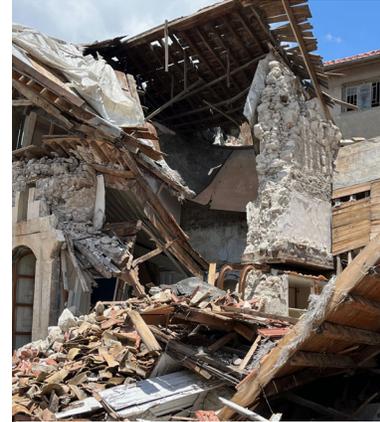
The target home is a single-story building made of rubble-stone masonry with a second floor wooden extension added to it. The gable wall of the second floor extension is made of masonry and was added on top of the masonry partition wall on the first floor, and it is believed that the large opening in the partition wall caused the second floor gable wall to collapse during the earthquake, resulting in extensive damage.

Target house:
The collapsed east gable wall of the second-floor extension

or the connections to the wooden structure, cannot withstand the out-of-plane seismic forces that occur on the gable wall. For this reason, the proposal is to retain the wooden extension on the second floor but to use wooden construction on both gable walls, as well as limit the masonry construction to the first floor.

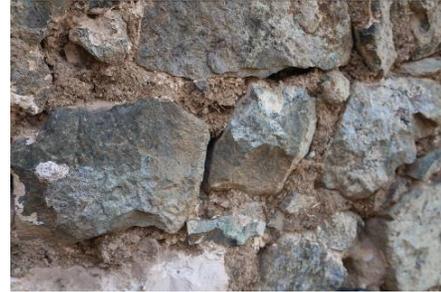
The compressive strength of earth mortar is only about one-tenth that of modern cement mortar, and the fracture strength of such masonry is determined by the minimum of the mortar strength or the bond strength between the aggregate. In fact, looking at the failure properties of the rubble-stone masonry walls in the old city of Antakya, it is the failure of the mortar that causes the failure of the masonry walls. Therefore, if modern

Poor earth mortar

Therefore, in order to achieve improved, sustainable earthquake resistance, it is desirable to minimize the damage caused by earthquakes. The first suggestion, therefore, is to use modern cement mortar in the rubble-stone masonry to enhance wall strength. While earth mortar, which has minute voids, is said to have excellent moisture absorption and release properties, similar to Japanese clay walls, which contribute to a good indoor environment, since the voids also reduce strength, this proposal prioritizes improving earthquake resistance.

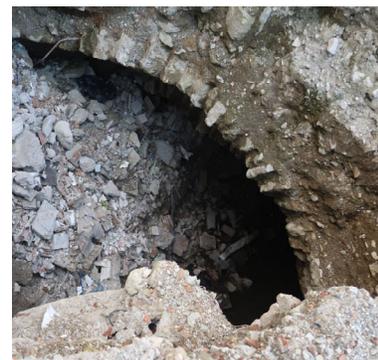
A drilling survey conducted near the Greek Orthodox Church in Antakya after the earthquake revealed that about 3 m beneath the surface was a layer of rubble, about 4 m below that was a layer of consolidated alluvial clayey soil, and more than 7 m below the surface was a layer of strongly weathered rock. Given Antakya's long history, it can be assumed that there are ruins, remains, and artifacts buried near the surface, but, apart from the surface layer of rubble, the ground is strong enough to support low-rise housing and is unlikely to

Exposed Roman culvert

On the other hand, though, the upper rubble-stone masonry wall is fragile and may crack even with slight deformation or uneven settlement, so a highly rigid foundation is required. Therefore, we propose a raft foundation made of reinforced concrete mat slab (a single thick foundation slab) be used.

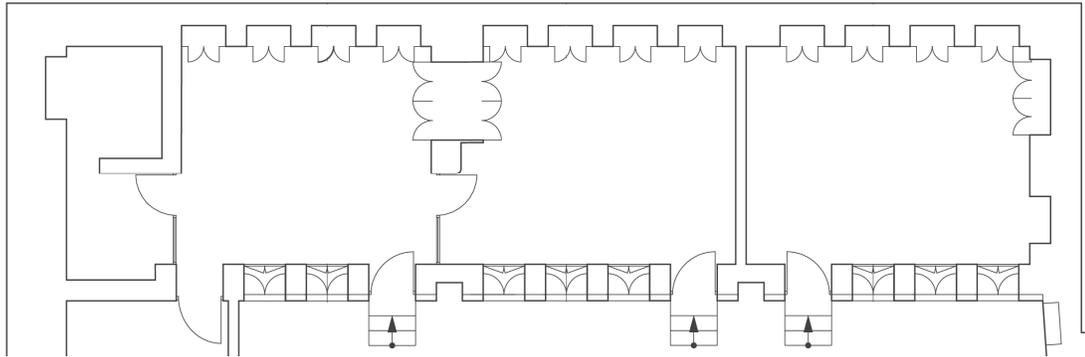
In addition, since it is assumed that some or all of the masonry partition walls had been

Target house: Original floor plan before the earthquake

removed or reduced, this proposal, in order to improve earthquake resistance, calls for the restoration of structures that are presumed to have been there originally. In addition, traditional Antakya houses are basically separated into individual rooms, with access to a courtyard on the first floor and a terrace on the second floor. As a result, each room has its own entrance to the outside.

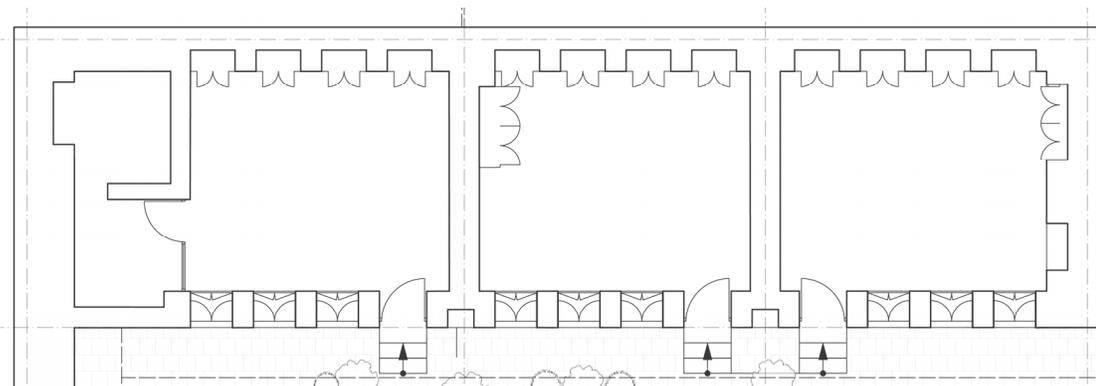
Proposed floor plan

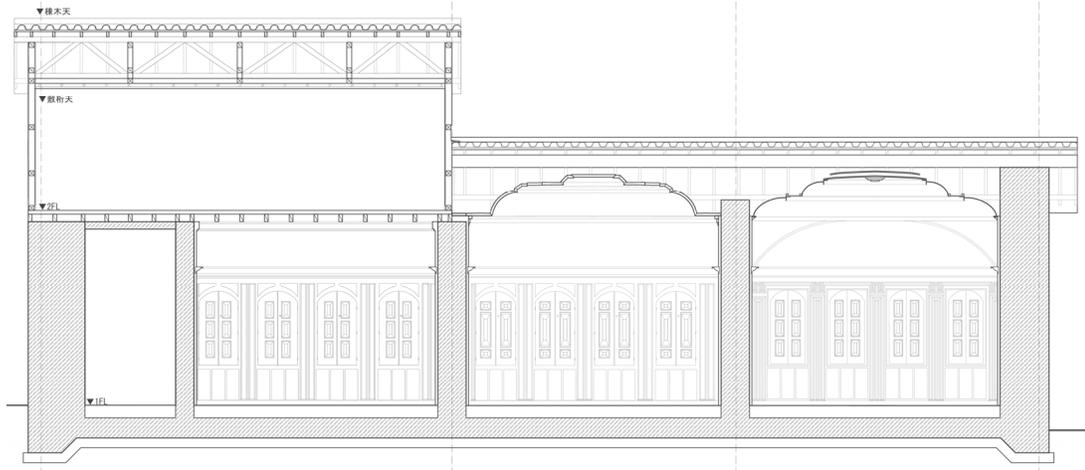
However, in this particular case, the wooden portion of the second floor is small, and, as long as the bracing is adequate, earthquake resistance is believed to be sufficient even with traditional construction methods. Rather, the cause of the earthquake damage in this case is believed to be the masonry construction of the second floor gable wall. In the first place, the wooden structure,

Proposed cross section

The partition wall on the first floor is reproduced, and the masonry gable wall on the second floor is removed, leaving the second floor entirely made of wood.
