## **Proposals for Strengthening the Earthquake Resistance of Traditional Residential Architecture in Antakya (Ideal model)**

- (1) Enhance the strength of mortar used in rubble-stone masonry construction.
- (2) Use a raft foundation (mat foundation) made of reinforced concrete mat slab for the foundation.
- (3) Ensure horizontal rigidity by making the second floor of reinforced concrete.
- (4) Put reinforcement in the rubble-stone masonry wall and rigidly connect it to the foundation slab and floor slab.
- (5) Enhance the strength of the wooden joints on the second story.

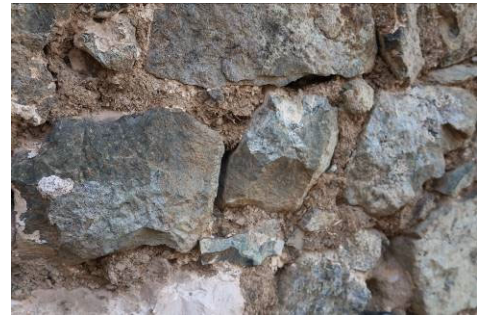
Poor earth mortar

The rupture strength of concrete is determined by the minimum of the aggregate strength, mortar strength and bond strength between the aggregate and mortar, but, looking at the failure properties of the rubble-stone masonry walls in the old city of Antakya, it is the failure of the mortar that causes the failure of the masonry walls. The compressive strength of earth mortar is only about one-tenth that of modern cement mortar. Therefore, if modern cement mortar is used in rubble-stone masonry, its strength will be increased to the same level as cement concrete, and its earthquake resistance will be dramatically improved.

Therefore, in order to achieve improved, sustainable earthquake resistance, it is desirable to minimize the damage caused by earthquakes. The first suggestion, therefore, is to use modern cement mortar in the rubble-stone masonry to enhance wall strength. Earth mortar contains fine voids, and like Japanese clay walls, it has excellent moisture absorption and release properties, contributing to its prominent improvement of the indoor environment, but the fine voids also reduce

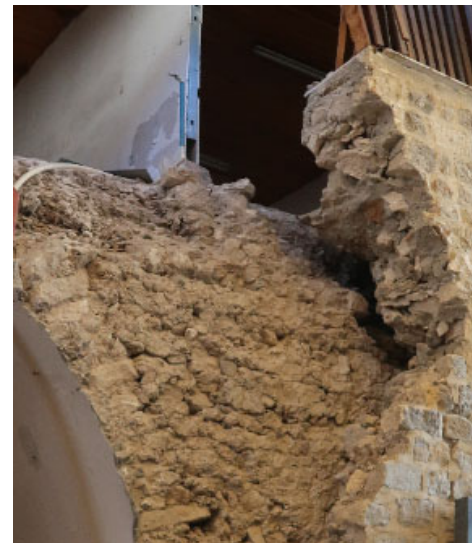
Damaged state of a rubble-stone masonry wall

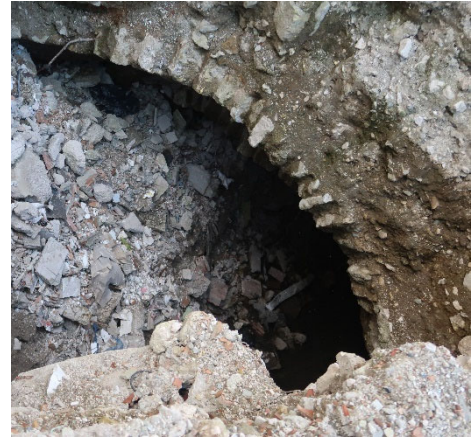
Exposed Roman culvert

The old city of Antakya is located at the southeastern end of Antakya Graben on a plateau formed by the accumulation of sediment from the Asi River at the foot of the Habib-i Nejjar Mountain and on terraces. Given Antakya's long history, it can be assumed that there are ruins, remains and artifacts buried near the surface, and a boring survey conducted near the Greek Orthodox Church in Antakya after the earthquake revealed that about 3 m beneath the surface was a layer of rubble, about 4 m below that was a layer of consolidated alluvial clayey soil, and more than 7 m below the surface was a layer of strongly weathered rock.

Therefore, apart from the surface layer of rubble, the ground is strong enough to support low-rise housing and is unlikely to sink. Pile foundations penetrating the rubble deposits could be considered, but if consideration is given to preserving the ruins, a non-invasive foundation construction method is required.

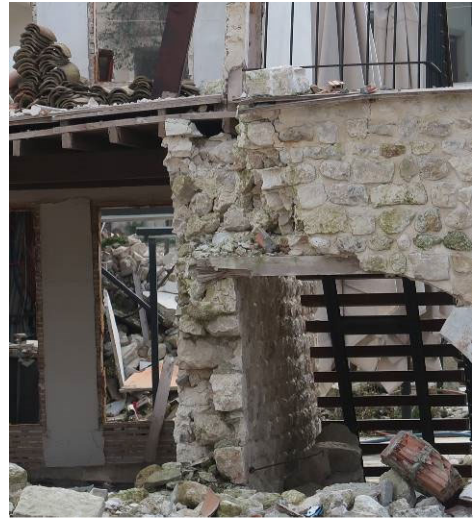
Rubble-stone masonry walls and wooden floors

In the traditional residential architecture of Antakya, wooden beams are placed on top of the rubble-stone masonry walls of the first story, and a wooden floor structure is laid on top of that. Masonry walls have strength and rigidity against in-plane horizontal forces, but they are weak against out-of-plane horizontal forces. Therefore, for masonry construction to be earthquake-resistant, the out-of-plane horizontal forces occurring in the wall must be transmitted to the orthogonal wall (as in-plane horizontal forces) by the floor, and therefore the floor is an essential structural element.

joint between the floor and the masonry walls are not necessarily designed with this in mind. Even if a wooden floor has strength against in-plane horizontal forces, wood has lower rigidity than other building materials and cannot ensure sufficient horizontal rigidity.

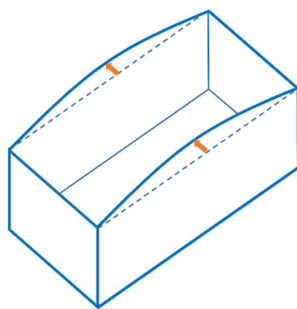
Out-of-plane deformation of the upper part of the wall

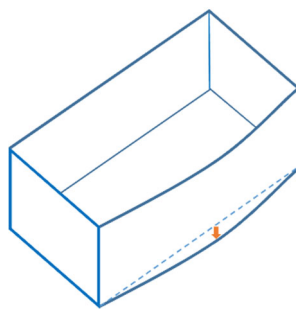
Uneven settlement at bottom of wall

On the other hand, though, the upper rubble-stone masonry wall is fragile and may crack even with slight deformation or uneven settlement, so a highly rigid foundation is required. Therefore, we propose a raft foundation made of reinforced concrete mat slab (a single thick foundation slab) be used.

By using a mat slab, the upper rubble-stone masonry wall can be integrated, preventing uneven settlement and localized horizontal movement. At the same time, by using a raft foundation (mat foundation), the ground reaction forces can be averaged out, minimizing the impact on ruins and artifacts buried underground.

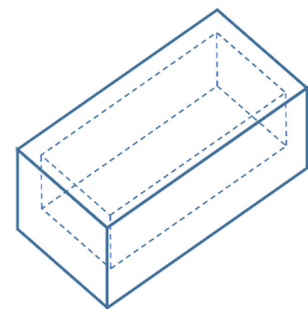
A rigid, box-shaped structure that does not cause local deformation

By placing a reinforced concrete foundation slab at the bottom of the masonry walls and a reinforced concrete floor slab at the top, the masonry walls can be integrated to form a sturdy, box-shaped structure which has extremely high earthquake resistance. Its structure is equivalent to Japan's reinforced concrete bearing-wall structure, and its earthquake resistance has been proven in past earthquakes.

To form a box-shaped structure, it is necessary to ensure the foundation slab and the masonry wall, as well as the masonry wall and the floor slab, are reliably joined. For this, we propose using a minimum amount of reinforcing bars in masonry walls to ensure joint strength.

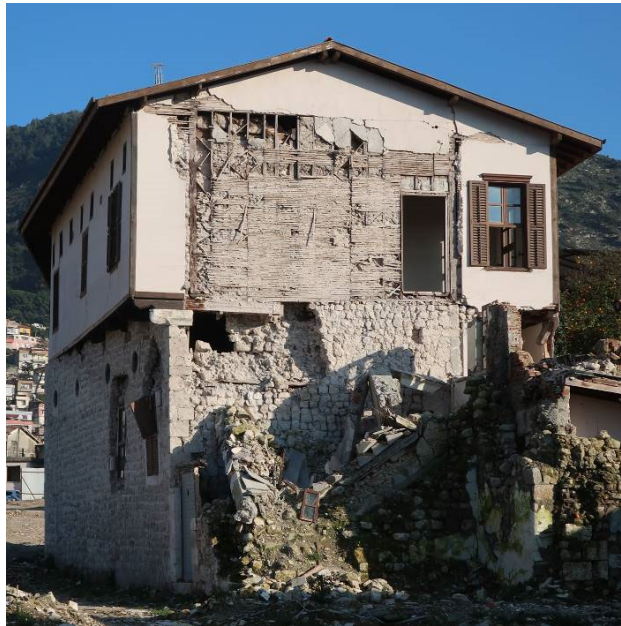
Rubble-stone masonry and Bağdadi exterior walls

The majority of residential buildings registered, or proposed for registration, as historic structures in Antakya are two-story court-house-style homes. The first story is made using rubble-stone masonry; the second story is made of Turkish-style wooden frame construction with a tiled roof; the first-story exterior wall facing the courtyard utilizes ashlar cladding; and the second-story exterior wall is generally made of a wooden lath base, called “Bağdadi,” with a plaster coating.

On the other hand, Antakya's traditional wooden frame construction method uses cross braces and wooden laths (Bağdadi) instead of plywood, nails instead of metal fittings and screws, and pebbles and mud walls instead of insulation material, and it is not only weaker in strength and rigidity than current frame construction methods, but also heavier. Therefore, improvements that bring the methods used as close as possible to current frame construction methods are desirable.

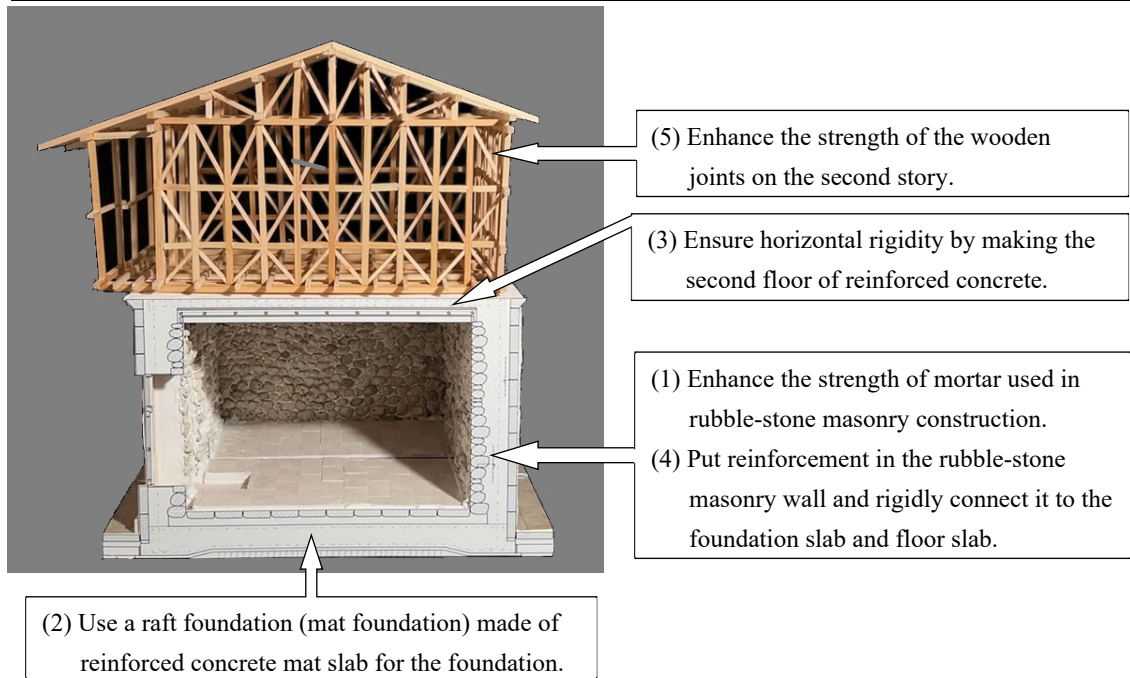
**Model of a traditional Antakya house that has been made earthquake-proof based on these proposals**
