## **Proposals for Strengthening the Earthquake Resistance of Traditional Residential Architecture in Antakya (Ideal model)**

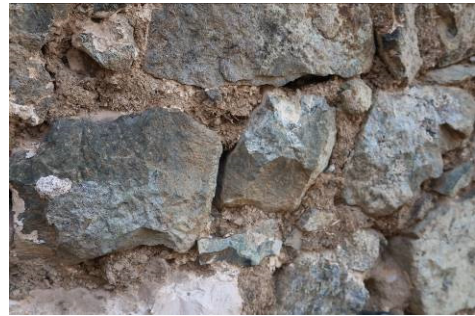
Poor earth mortar

The rupture strength of concrete is determined by the minimum of the aggregate strength, mortar strength and bond strength between the aggregate and mortar, but, looking at the failure properties of the rubble-stone masonry walls in the old city of Antakya, it is the failure of the mortar that causes the failure of the masonry walls. The compressive strength of earth mortar is only about one-tenth that of modern cement mortar. Therefore, if modern cement mortar is used in rubble-stone masonry, its strength will be increased to the same level as cement concrete, and its earthquake resistance will be dramatically improved.

Therefore, in order to achieve improved, sustainable earthquake resistance, it is desirable to minimize the damage caused by earthquakes. The first suggestion, therefore, is to use modern cement mortar in the rubble-stone masonry to enhance wall strength. Earth mortar contains fine voids, and like Japanese clay walls, it has excellent moisture absorption and release properties, contributing to its prominent improvement of the indoor environment, but the fine voids also reduce

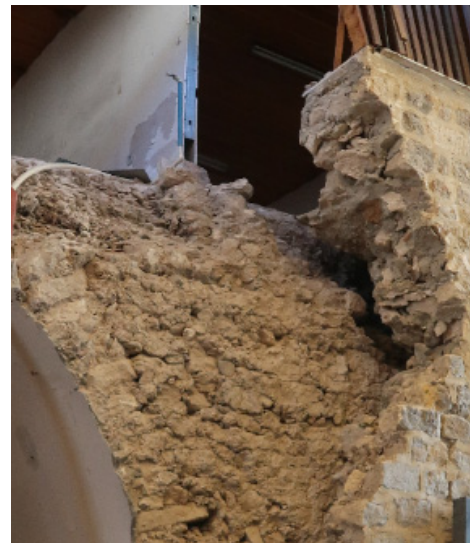
Damaged state of a rubble-stone masonry wall

If we look only at the amount of walls, which determines the earthquake resistance of a building, it is far greater than that of traditional Japanese houses, and the buildings’ external shape gives them a highly earthquake-resistant character. Nevertheless, the cause of the collapse must be attributed to the walls’ weakness in terms of strength and ductility.

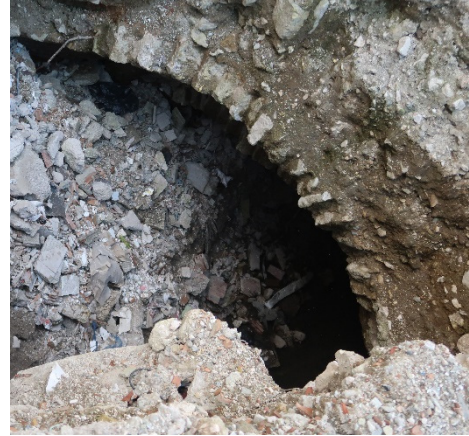
Exposed Roman culvert

The old city of Antakya is located at the southeastern end of Antakya Graben on a plateau formed by the accumulation of sediment from the Asi River at the foot of the Habib-i Nejjar Mountain and on terraces. Given Antakya's long history, it can be assumed that there are ruins, remains and artifacts buried near the surface, and a boring survey conducted near the Greek Orthodox Church in Antakya after the earthquake revealed that about 3 m beneath the surface was a layer of rubble, about 4 m below that was a layer of consolidated alluvial clayey soil, and more than 7 m below the surface was a layer of strongly weathered rock.

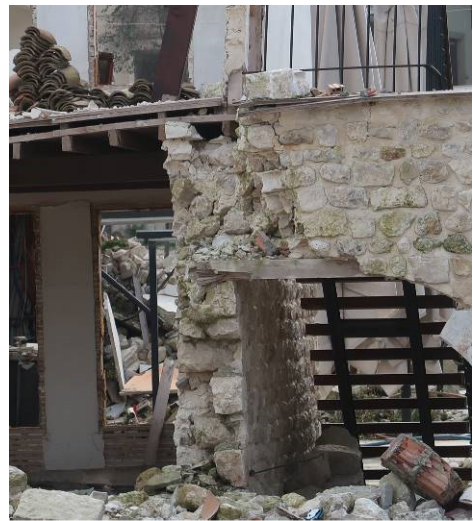
Rubble-stone masonry walls and wooden floors

In the traditional residential architecture of Antakya, wooden beams are placed on top of the rubble-stone masonry walls of the first story, and a wooden floor structure is laid on top of that. Masonry walls have strength and rigidity against in-plane horizontal forces, but they are weak against out-of-plane horizontal forces. Therefore, for masonry construction to be earthquake-resistant, the out-of-plane horizontal forces occurring in the wall must be transmitted to the orthogonal wall (as in-plane horizontal forces) by the floor, and therefore the floor is an essential structural element.

joint between the floor and the masonry walls are not necessarily designed with this in mind. Even if a wooden floor has strength against in-plane horizontal forces, wood has lower rigidity than other building materials and cannot ensure sufficient horizontal rigidity.

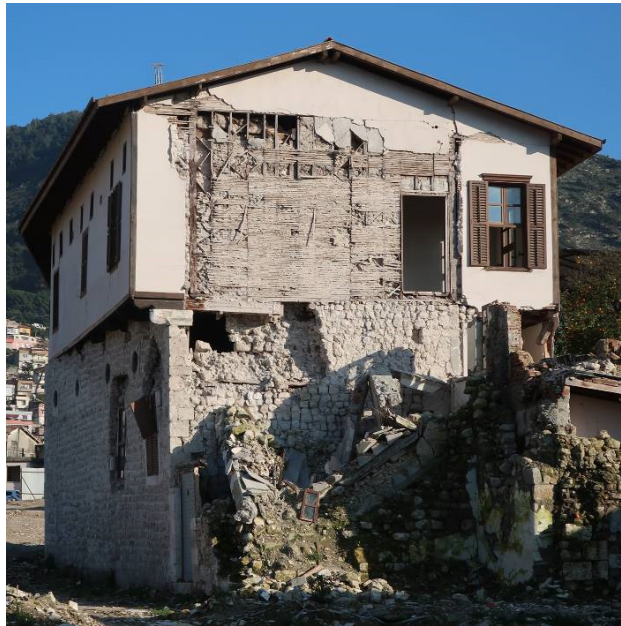
Rubble-stone masonry and Bağdadi exterior walls

The majority of residential buildings registered, or proposed for registration, as historic structures in Antakya are two-story court-house-style homes. The first story is made using rubble-stone masonry; the second story is made of Turkish-style wooden frame construction with a tiled roof; the first-story exterior wall facing the courtyard utilizes ashlar cladding; and the second-story exterior wall is generally made of a wooden lath base, called “Bağdadi,” with a plaster coating.

On the other hand, Antakya's traditional wooden frame construction method uses cross braces and wooden laths (Bağdadi) instead of plywood, nails instead of metal fittings and screws, and pebbles and mud walls instead of insulation material, and it is not only weaker in strength and rigidity than current frame construction methods, but also heavier. Therefore, improvements that bring the methods used as close as possible to current frame construction methods are desirable.
