Proposal for Seismic Retrofit Design of a Traditional Residential Building in Antakya (Structural Design Proposal)

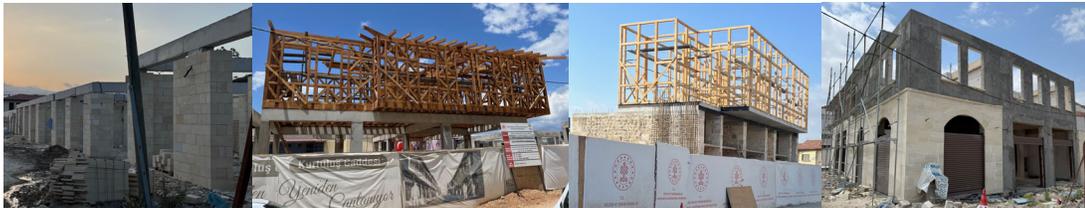
Reconstruction work by both public and private organizations is underway in some areas of the city. Many of these buildings have a reinforced concrete rigid frame structure on the first floor, but masonry curtain walls are used to maintain a traditional appearance. The second floor also uses traditional wooden frame construction. However, there are also a number of reconstructed buildings whose structural type cannot be clearly determined from their exterior.

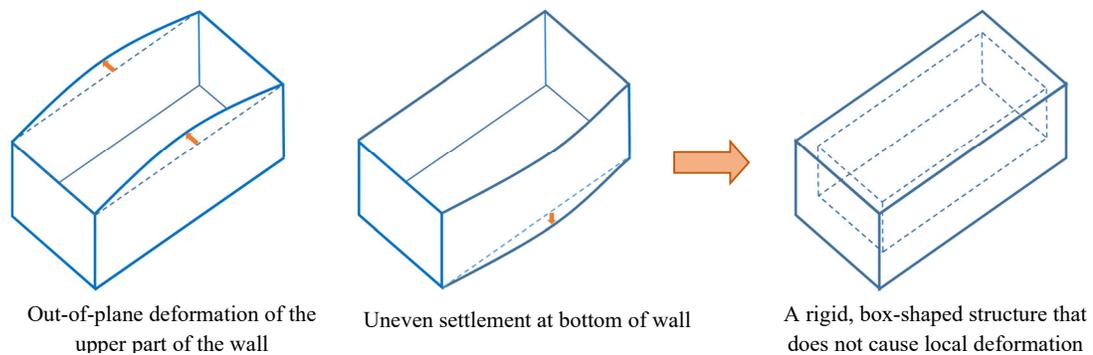
On the other hand, though, the upper rubble-stone masonry wall is fragile and may crack even with slight deformation or uneven settlement, so a highly rigid foundation is required. Therefore, we propose a raft foundation made of reinforced concrete mat slab (a single thick foundation slab) be used.

By using a mat slab, the upper rubble-stone masonry wall can be integrated, preventing uneven settlement and localized horizontal movement. At the same time, by using a raft foundation (mat foundation), the ground reaction forces can be averaged out, minimizing the impact on ruins and artifacts buried underground.

Since the mechanical properties of the rubble layer buried underground are unpredictable, there is a possibility that the building may tilt due to an earthquake; however, even if the building does tilt, by using a mat-slab structure, the building will not deform but tilt as a whole. Even if the building does tilt, the tilt can be easily corrected by drilling holes in the mat slab and injecting mortar between the foundation slab and the ground.

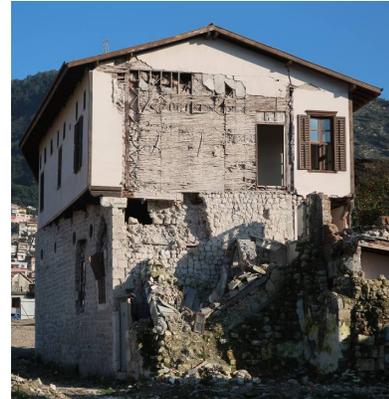
Example of rubble-stone masonry and Bağdadi exterior walls

The joints in frame construction are not rigid, so braces are needed to keep the frame stable during construction, but the amount and placement of braces vary depending on the building. A bracing system that meets the requirements of TBEC-2018, or a plywood alternative to bracing, is required. In addition, since the in-plane horizontal strength and rigidity of the roof surface can be ensured by laying sheathing boards, TBEC-2018 does not specify regulations for the roof surface, but it does require junctions that can ensure the in-plane horizontal strength of the roof surface.
